## Evaluation of a Retrofit OH-58 Pilot's Seat to Prevent Back Injury

Joseph L. Haley, Jr.  
COBRO Corporation

December 1994

United States Army Aeromedical Research Laboratory  
Fort Rucker, Alabama 36362-0577

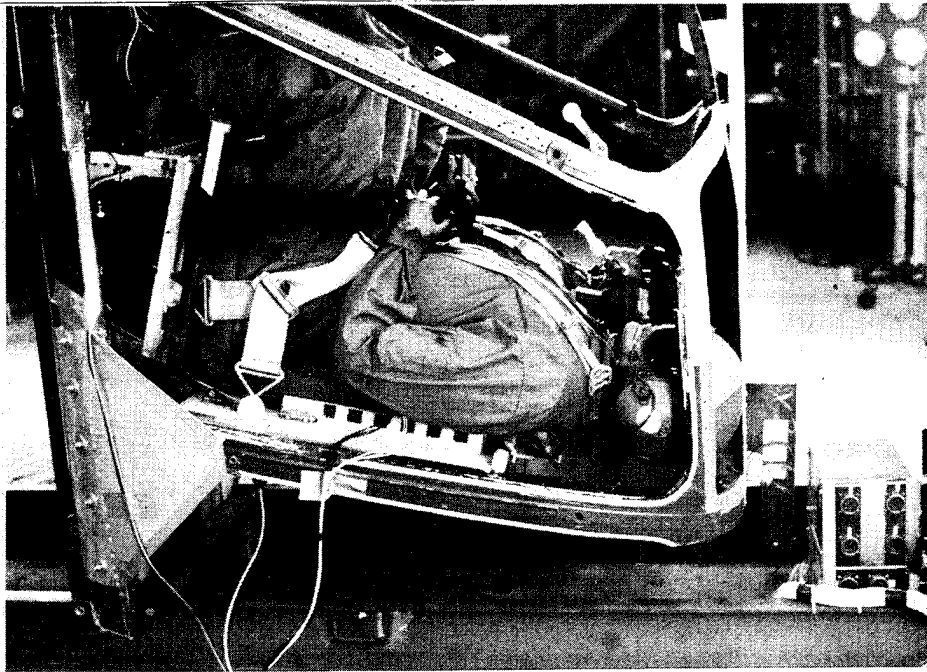
Figure 20. Posttest view of test 88058, showing 95th percentile VIP dummy (note the .05-inch thick aluminum sheet used to stabilize the floor-to-bulkhead joint, and the slack in the wire bender at point "W").

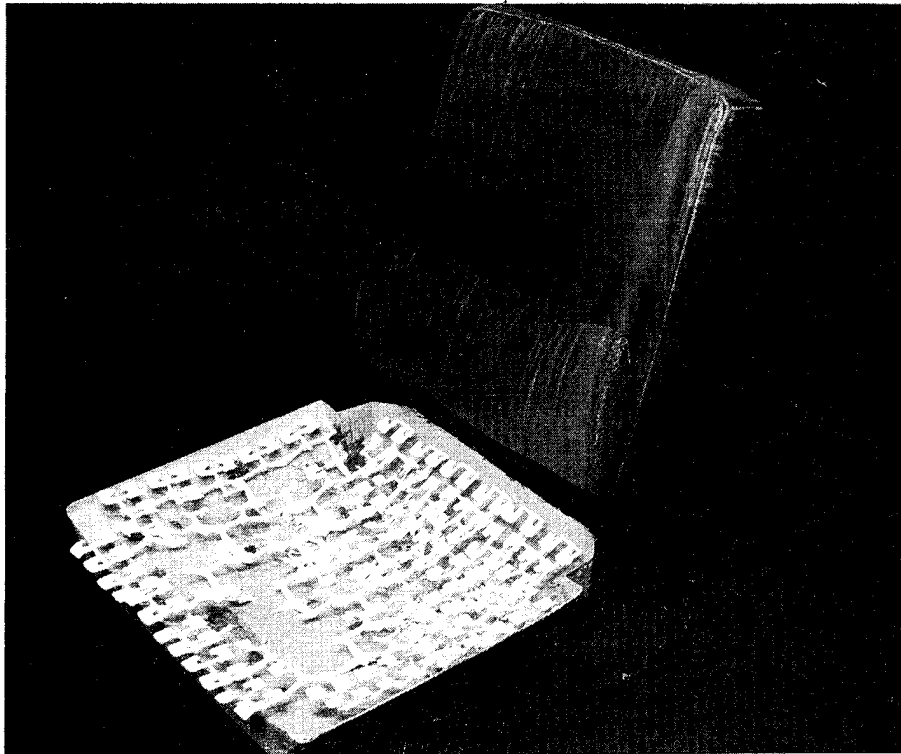
The degraded PREQUAL™ was replaced with foam cushions (cut to size) from wrecked UH-60 seats, and the frayed, worn SPACEFABRIC™ was replaced with black sheepskin covers, also from UH-60 wrecked seats. A recent inspection reveals the seat cushions are still serviceable, but the sheepskin is faded somewhat after 4 years exposure in the JOH-58A. Unless SPACEFABRIC™'s resistance to sunlight is improved, the sheepskin material appears to be a viable candidate to replace it.

Figure 36a. Copilot seat bottom and back cushions after removal of PREQUAL<sup>™</sup> cover after 20 months and 100 flight hours in JOH-58A (Ser 71-20778).

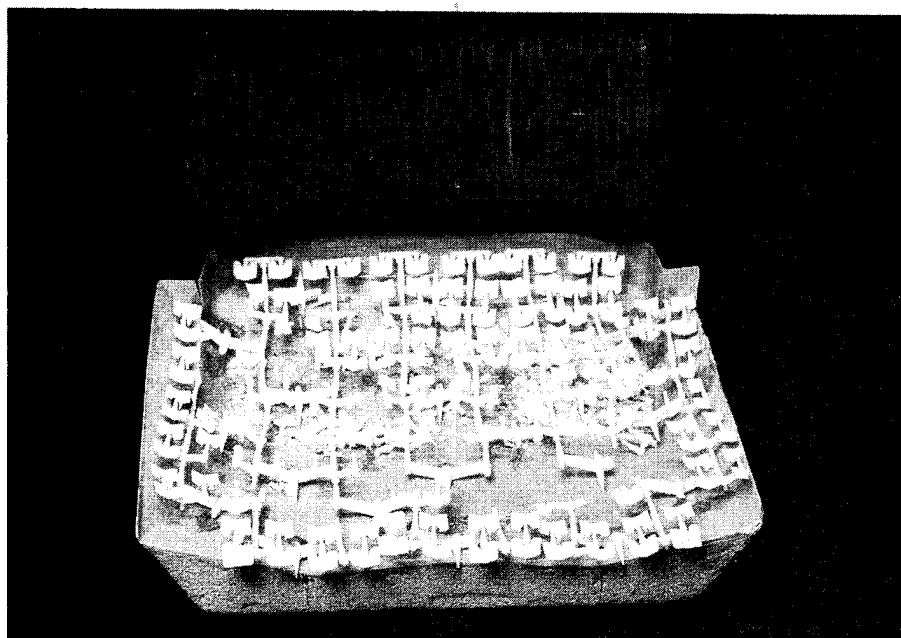
Figure 36b. Copilot (left) seat bottom and back cushions (note disintegrated plastic lever supports).
